Analysis of Neutral Ground Resistance Behavior of Fourth Refinery Gas Power Plant in Real Short Circuit Faults

Abstract – The Fourth Refinery is one of the largest refineries in Iran due to its vast area as well as its extensive equipment. This refinery includes three gas phases consisting of six operational trains. The vastness of this refinery combined with its involved processes as well as equipment frequency and complexity make it stand out among other refineries, so much so that every minute a train has to be turned off would lead to irreparable and heavy financial losses. The neutral points of the 11kV/33kV transformers supplying electricity to The Fourth Refinery are earth-connected through NGRs (neutral ground resistors). The transformer NGRs are equipped with tap changers which are damaged and burned without the utilizer’s knowledge in the event of a short circuit. Therefore, any kind of short circuit in the power system of The Fourth Refinery would damage the protective NGRs and CTs, thus destroying the system protection units, which might in turn lead to tripping of the refinery as a whole. For this reason, an attempt was made in the present article to solve this proble

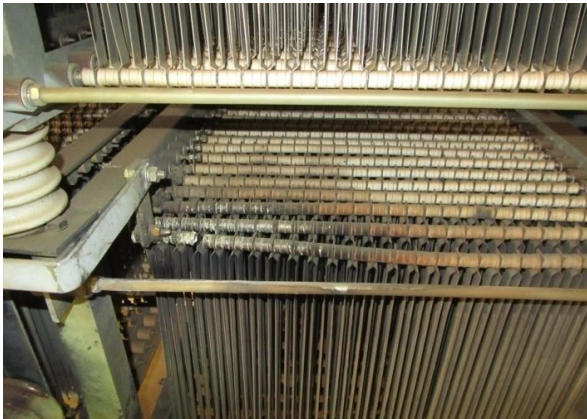
During the visits to the site where the faults had occurred, we found that the insulators supporting the ribbon resistors as well as the resistors themselves had broken (Fig. 4). At some points, the electrical connection had been cut off and at a significant number of other points, the ribbon resistors had been separated, leading to NGR open circuits. In many parts, the failure was accompanied with sparks. This indicated that some NGR points had been exposed to transient over voltages. On the other hand, as the supporting rod of the resistors and even the ribbon resistors had melted, we concluded that the NGR had been subjected to current stresses and that the

resistors could not withstand the passing current resulting from the short circuit. These points are unclear since there is not enough information regarding the failure of the NGRs.

Fig. 4: The damaged NGRs (a) failure of the ribbon resistors and (b) their supporting insulators

1. Installing a monitoring system: We have attempted in this research to build an economical color display with the least wiring and modification, capable of monitoring the required processes.
2. Replacing unit taps each time a unit enters or exits the power plant: This is necessary because if the taps are not replaced at each entry or exit, the unit's earth connection system is turned into either a high resistance or a low resistance system.
3. Changing the material and type of the NGR resistors. We propose that the present "stamped ribbon resistors" be substituted with "stamped grid resistors".

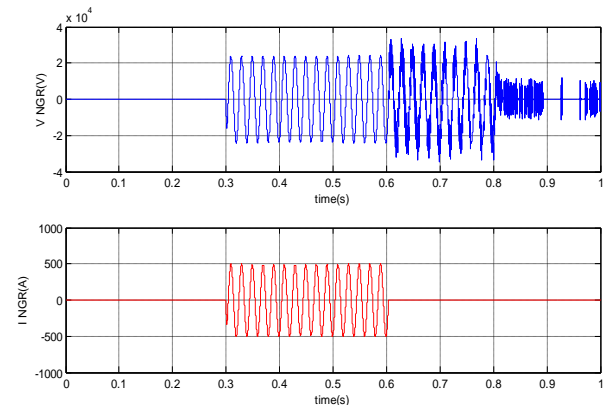
Fig. 13 shows that at $t=0.3$ s when the fault occurs, the NGR voltage increases by approximately 19 kV, causing a 400 A current to pass through the same. Then, at $t=0.6$ s when the NGR is accidentally open circuited, over voltage and electric arcs were experienced by the NGR followed by sparks on the NGR and its body. It is possible that the insulators and the dielectric materials used for isolating the NGR electrically were unable to withstand this overvoltage. After this,, the current passing through the NGR dropped to zero as expected.

Fig.13. NGR voltage and current obtained for 15TR1 under single-phase ground short circuit in the case of NGR disconnection during fault conditions

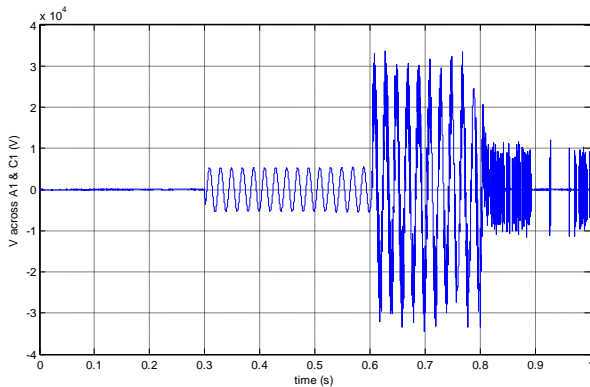
Fig. 14 shows the NGR voltage between A1 and C1 under single phase to ground short circuit when the NGR is open circuited during the fault. As can be seen, occurrence of the fault at $t=0.3$ s established a 3.5 kV voltage across the NGR. At $t=0.6$ s, the NGR was open circuited, and consequently, a 21 kV overvoltage was experienced by the NGR. Obviously, the dielectric gaps are unable to withstand such an overvoltage t A1 and C1. Thus, most failures must have occurred at Stage 4. This overvoltage remained at the neutral point of the system even after the short circuit to ground fault was removed due to the NGR's being open circuited.

Fig.14. NGR voltage between points A1 and C1 under single-phase ground short circuit in the case of NGR disconnection during fault conditions

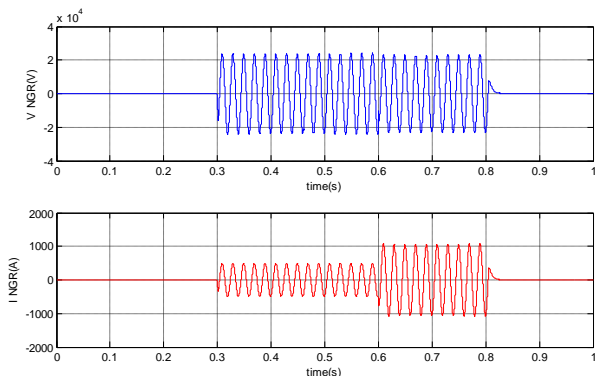
Fig. 15 shows the NGR voltage and current at 15TR1 under single phase to ground short circuit conditions for the case where the NGR is accidentally short circuited during the fault (i.e., a part of resistors are excluded from the circuit). No change can be observed in the NGR voltage waveform after the short circuit. However, regarding the current waveform, as seen from the figure, the constant voltage across the NGR is doubled due to the partial exclusion of the resistors from the circuit. The ribbon resistors cannot withstand this double current and burn as a result.

Fig.15. NGR voltage and current for 15TR1 under single-phase ground short circuit in the case of partial NGR disconnection during fault conditions

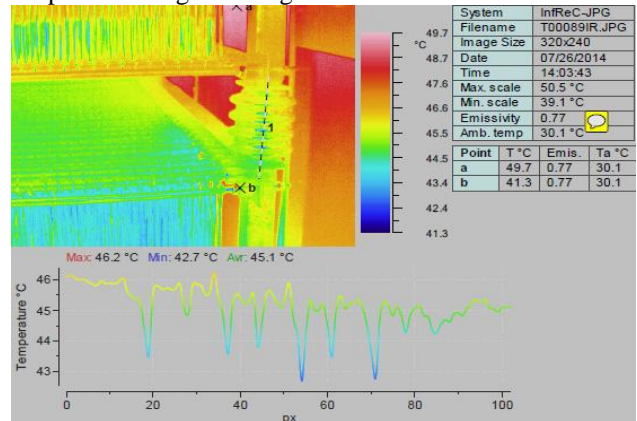
Fig. 16 shows the thermography test results at points a and b. This test was conducted on a transformer NGR at the power plant under normal operating conditions. As can be observed from the figure, maximum temperature occurs

at Point a (70.1 C). This is within the allowable temperature range as designated in the IEEE32 standard.

Fig.16. Thermography results at points a and b

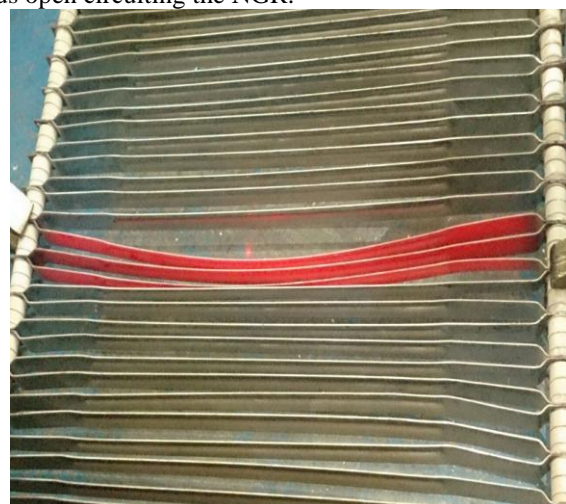
Upon establishing the rated current across Stage No. 4, the ribbon resistors of this stage failed within 10 seconds. Fig. 20 shows the results of this test. Therefore, the ribbon resistors could not withstand the rated current and failed, thus open circuiting the NGR.

Fig. 20: Rated current test conducted on each NGR stage
(a) resistors could not withstand the rated current (b) open circuiting the NGR
