Analysis of Neutral Ground Resistance Behavior of Fourth Refinery Gas Power Plant in Real Short Circuit Faults

Abstract – The Fourth Refinery is one of the largest refineries in Iran due to its vast area as well as its extensive equipment. This refinery includes three gas phases consisting of six operational trains. The vastness of this refinery combined with its involved processes as well as equipment frequency and complexity make it stand out among other refineries, so much so that every minute a train has to be turned off would lead to irreparable and heavy financial losses. The neutral points of the 11kV/33kV transformers supplying electricity to The Fourth Refinery are earth-connected through NGRs (neutral ground resistors). The transformer NGRs are equipped with tap changers which are damaged and burned without the utilizer’s knowledge in the event of a short circuit. Therefore, any kind of short circuit in the power system of The Fourth Refinery would damage the protective NGRs and CTs, thus destroying the system protection units, which might in turn lead to tripping of the refinery as a whole. For this reason, an attempt was made in the present article to solve this proble

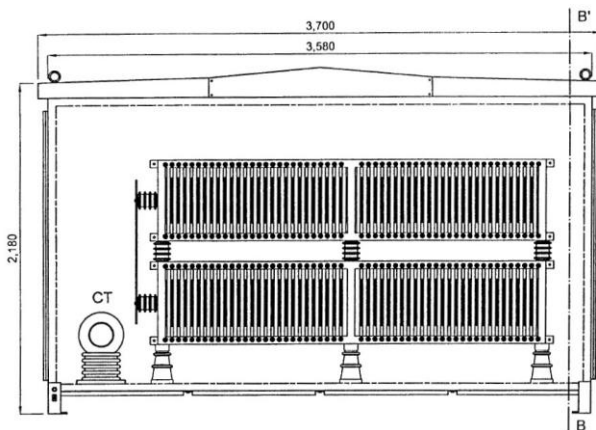
Each NGR consists of four stages designated with numbers 1, 2, 3, and 4. Stage 1 comprises 40 resistance elements in two parts (20 in each part) connected in series. Stages 2, 3, and 4 also have 54 resistance elements in two parts (each part comprising 27 resistance elements) connected in series. As shown in Fig. 2, Stage 1 has a 15.75 ohm resistor and Stages 2-4 have 42.3 ohm resistors. Each resistance element comprises 51 ribbon resistors connected via spot welding. The ribbon resistors are held by two metal rods and the ribbons are isolated from one another and from the rods through small insulators. The NGRs have two 127 ohm/200 A and 47.6 ohm/400 A taps. Fig. 3 shows the tap connection configurations.

Fig. 2: View of the NGR, the stages, and the CT

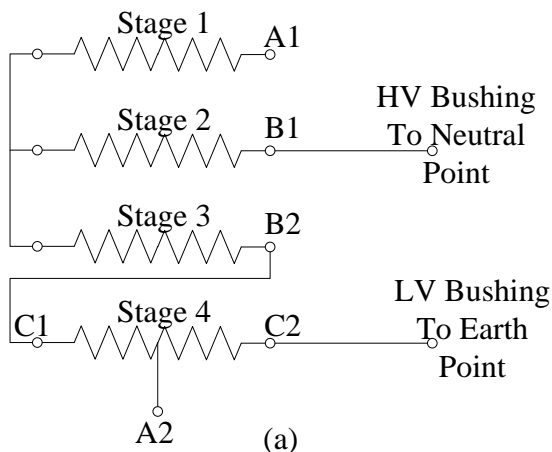
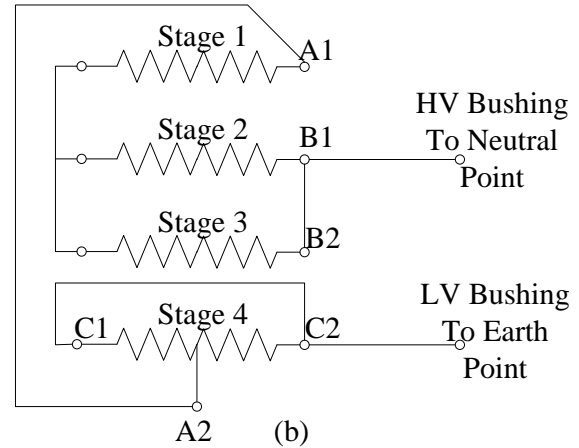
Fig.3. The connection configurations for (a) the 47.6 ohm and (b)127 ohm taps of the 11kV/33kV transformer NGR at The Fourth Refinery

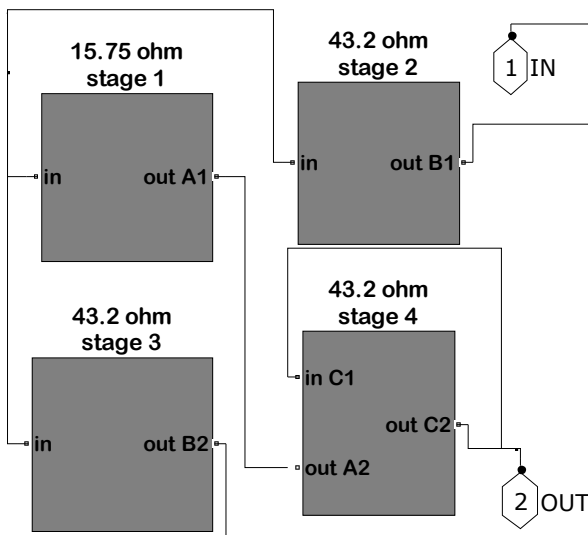
Fig. 6 shows the simulation blocks corresponding to various NGR stages with a 47.5 ohm tap. Stage No. 1 had a resistance of 15.75 ohms, and the resistance of the other stages (2, 3, and 4) was 42.3 ohm.

Fig.6. NGR simulation of the 47.5 ohm tap connection(see Fig.3)

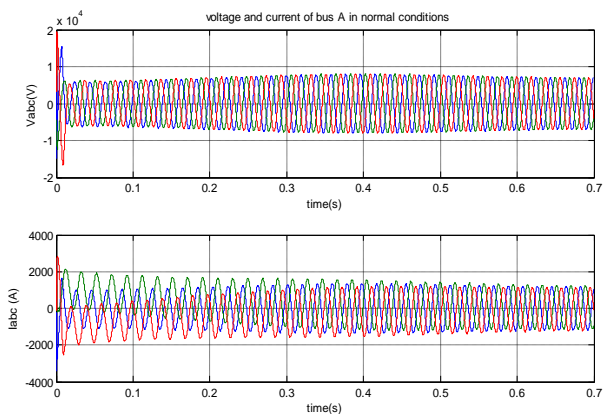
Fig. 7 shows line voltages and currents at Bus A, Station No. 1 under normal operating conditions. Fig. 8 shows the NGR voltage and current obtained for 15TR1 under normal conditions for the case when this transformer was the only transformer in operation in the circuit. As can be observed from these results, the voltages and currents at Bus A were well balanced. The same was true for all the other electric buses.

Fig.7. Line voltages and currents obtained for Station 1 of Bus A under normal working conditions

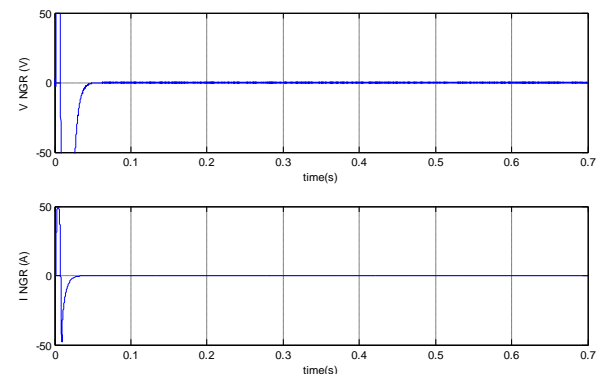
Fig.8. NGR voltage and current for 15TR1 under normal working conditions

Fig. 8 demonstrates that the voltage across the NGR is almost zero. This is also the case for the NGR current.

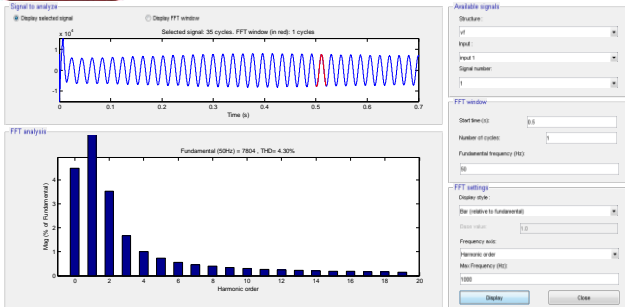
Percentage voltage harmonics in Bus A are shown in Fig. 9 (THD=4.3%). Fig. 10 shows the current percentage harmonics for Bus A (THD=7.65%). These are also in the normal range.

Fig.9. Percentage voltage harmonics for Station 1 of Bus A under normal working conditions

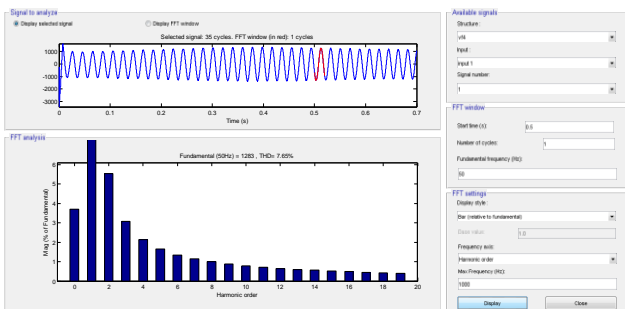
Fig.10. Percentage voltage harmonics for Station 1 of Bus A under normal working conditions

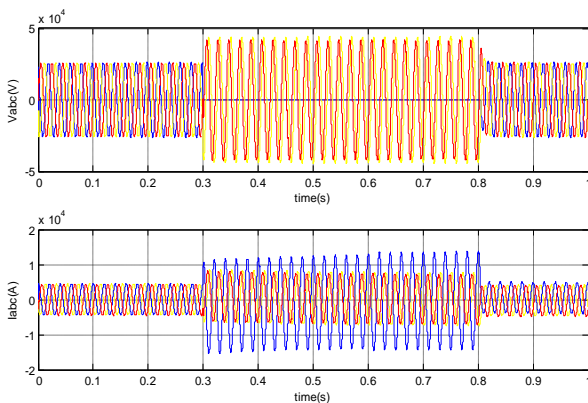
The line voltage and current results obtained upon applying a single phase short circuit at Bus A are presented in Fig. 11. In this case, the single phase short circuit was applied for 0.3 s and was over in 0.8 s. As can be seen, the grounded phase voltage changes to zero and the other two phase voltages were increased by $\sqrt{3}$. The grounded phase current was also increased.

Fig. 11: Line voltages and currents obtained for Station No. 1 of Bus A under single-phase ground short circuit

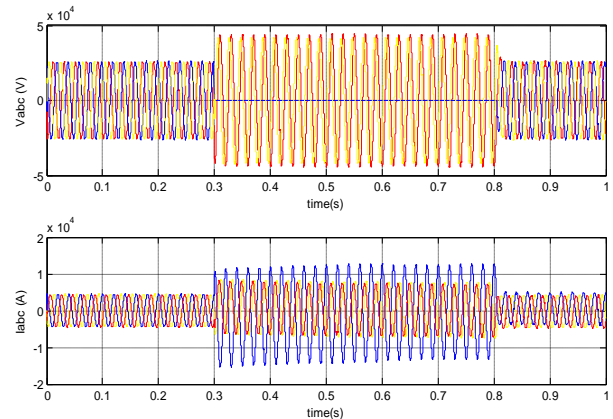
It was assumed in the simulation that at $t=0.6$ s, i.e., 0.3 seconds after applying the single phase to ground short circuit, the NGR is accidentally open circuited. It was also assumed that the short circuit ended at $t=0.8$ s. We open circuited the NGR at points A1 and A2 during simulation. Fig. 12 shows line voltages and currents of Bus A at Station No. 1. Fig. 13 shows the NGR voltage and current obtained for 15TR1 under single phase to ground short circuit conditions in the case when the NGR is open circuited during the short circuit. As can be seen, the voltage waveform did not change upon NGR's being open circuited. The current waveform amplitude decreased slightly as compared with the short circuited current.

However, this was negligible since the short circuit current would pass through the Mobin Power Plant NGR any way.

Fig.12. Line voltages and currents for Station No. 1 of Bus A under single-phase ground short circuit occurring at Bus A due to disconnecting the NGR

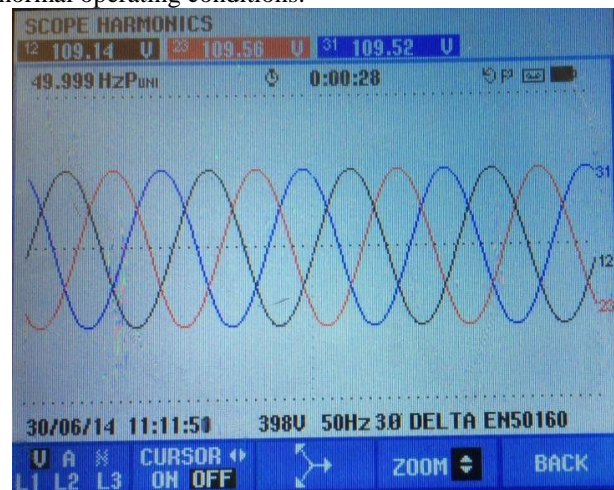
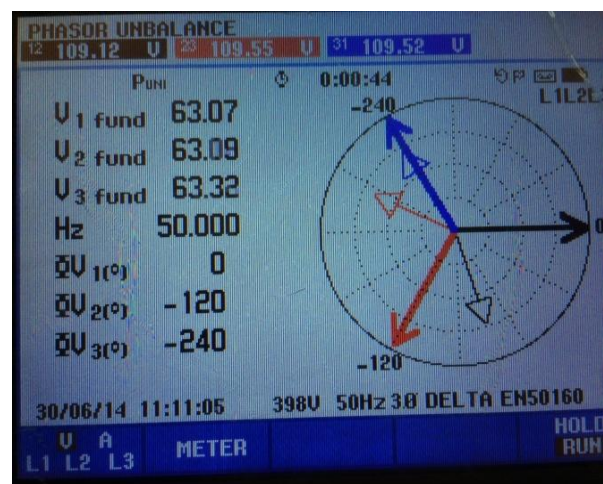
This test was conducted on the Power Station 1 buses using a power analyzer. The results are shown in Fig. 17. As can be seen, the phase voltages are balanced under normal operating conditions.

Fig.17. Voltage balance test conducted on the buses of Station No. 1 in the refinery (a) Voltage waveform (b) vector diagram

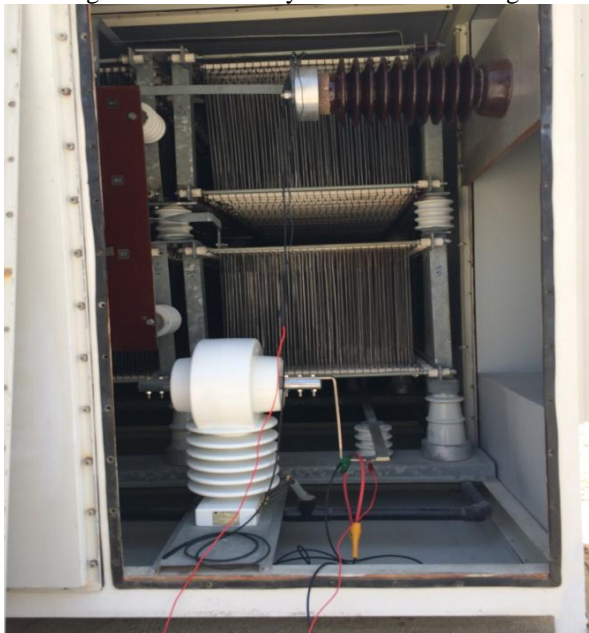
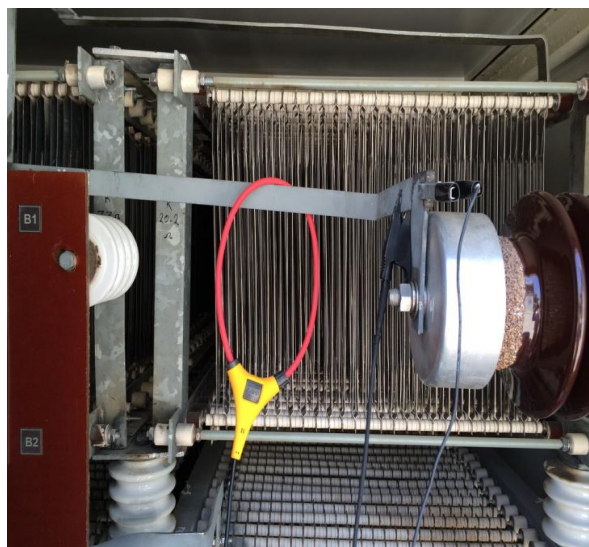
This test was conducted on the NGR using a power analyzer. The wiring method used in this test for connecting the NGR to the system is shown in Fig. 18.

Fig.17. NGR power analyzer wiring for conducting the harmonic test

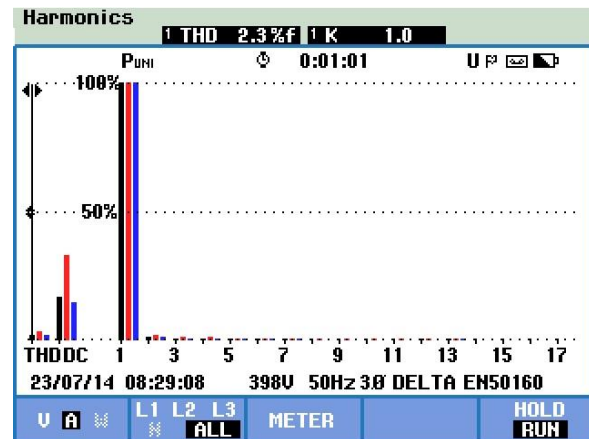
The following procedure was followed in the harmonics test: One out of service generator at the power plant was loaded in 2 MW steps up to 10 MW, and at each step, the NGR voltage and current were recorded (Table 3). At each step, the current harmonics were also measured. The current harmonics obtained for the first step are shown in Fig. 19 where the black strips are due to the measuring channel. Note that this test was conducted on a generator which was in synchronous operation with Mobin Power Plant. The results showed that the current harmonics are in the allowable range. It was, therefore, concluded according to [6] that the problem has not been caused by

Fig.19. Percentage harmonics: NGR current for 15TR1 at the first step (2MW) under normal working conditions
